**Chemical Resistance Testing of
HDPE Cabinet Corners**

Report Number: PDR 00/039

Date: 30 January 2001

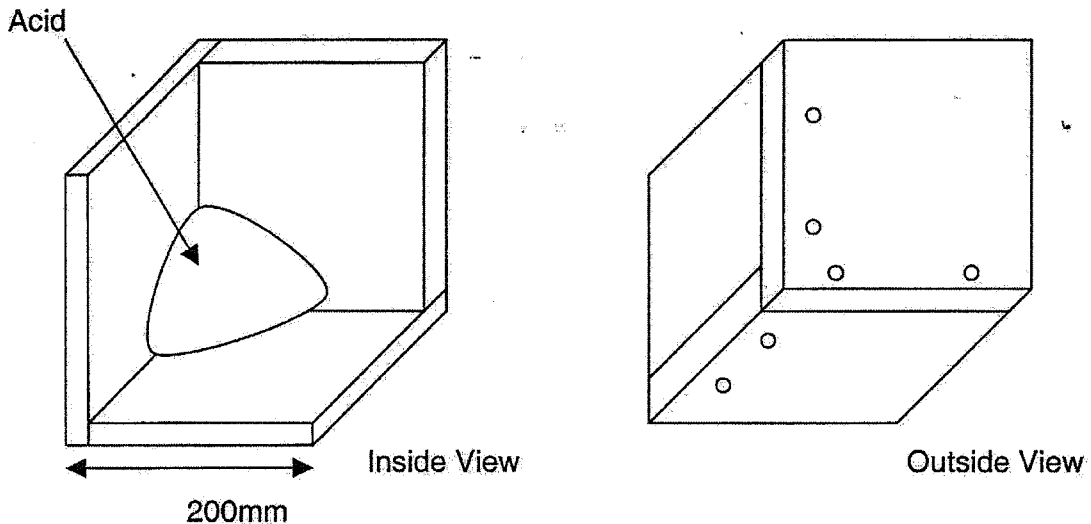
Figure 1 – HDPE corner

This report details the chemical resistance testing of HDPE chemical cabinet corners. Pratt Safety Systems supplied four HDPE corners, silicon sealed and screwed together with stainless steel screws, as shown in figure 1.
